Building Deficiency Review

at 323 George Street, Coburg, ON

Final Submission

PROJECT # 6383-01

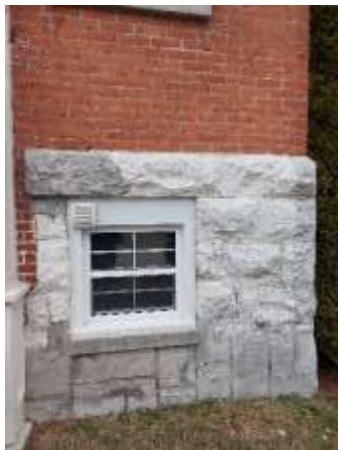
Photo 1: Masonry Cracking and Previous Repairs, Southwest Corner

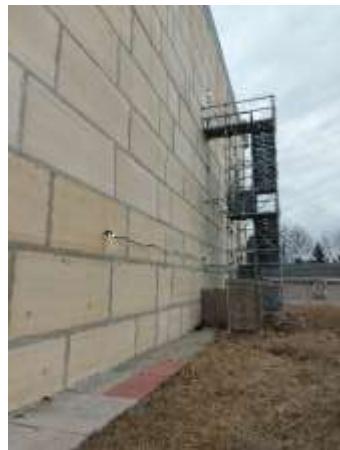
As part of our preliminary site review the cladding system for the west wall of the building was noted to consist of cement board panels. The review noted that the panels were anchored into plastic strips of the ICF assembly, with deck screws. In our opinion, the existing fastening is not adequate to resist code-required wind forces. In addition, we note signs of deterioration on the panels, which will reduce the panels' capacity to resist those forces. In our opinion, this condition represents an immediate hazard due to falling debris in strong winds.

- The west portion of the building is the new addition. This portion consists of insulated concrete forms (ICF) with masonry veneer at the north and south elevations. The west elevation has exposed cement board. It is our understanding that further additions were planned to connect at this elevation, therefore exterior cladding was not installed. Construction has not proceeded and unfinished cement board has remained exposed since installation. Cement board panels were noted to be bowed or bulging away from the building. Panels appeared to be fastened with adhesive and deck screws to plastic form work of the ICF. (*Photo 2*)

- A scaffold fire escape was also located at the west elevation. (*Photo 2*) Poured concrete footings were noted; however, details are unknown. The base of scaffold posts were anchored to concrete; only one or two anchors per post were noted, with limited edge distance, and cracking was observed in one location. Bracing elements appeared to be anchored to the building wall; however, it is unconfirmed if it ties into the concrete of the ICF wall.

Photo 2: Cement Boards and Scaffold Egress Stair, West Elevation

It was recommended to install fencing in front of the west wall to block-off the area from public access as per AAR's letter issued April 8, 2024. It was also recommended to erect overhead protection at the exterior scaffolding and as an egress path leaving the area.

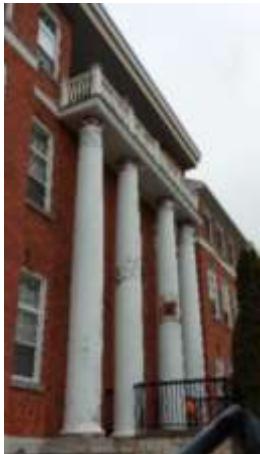
- There are four columns located at the east façade of the building which extend up to the underside of level 4 balconies. Significant cracking in parging was observed. Areas of previous openings were noted, which were further reviewed as discussed below, *Section 3.3*.

Photo 4: East Elevation Columns

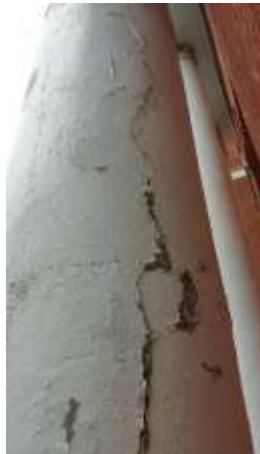
Photo 5: Cracking of Parging, Column 3

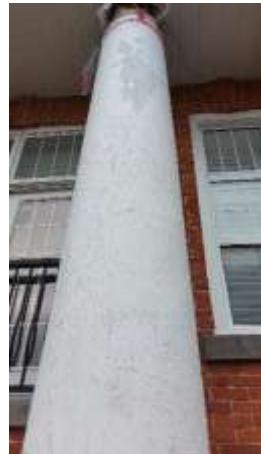
Photo 6: Cracking of Parging and Peeling Paint, Column 3

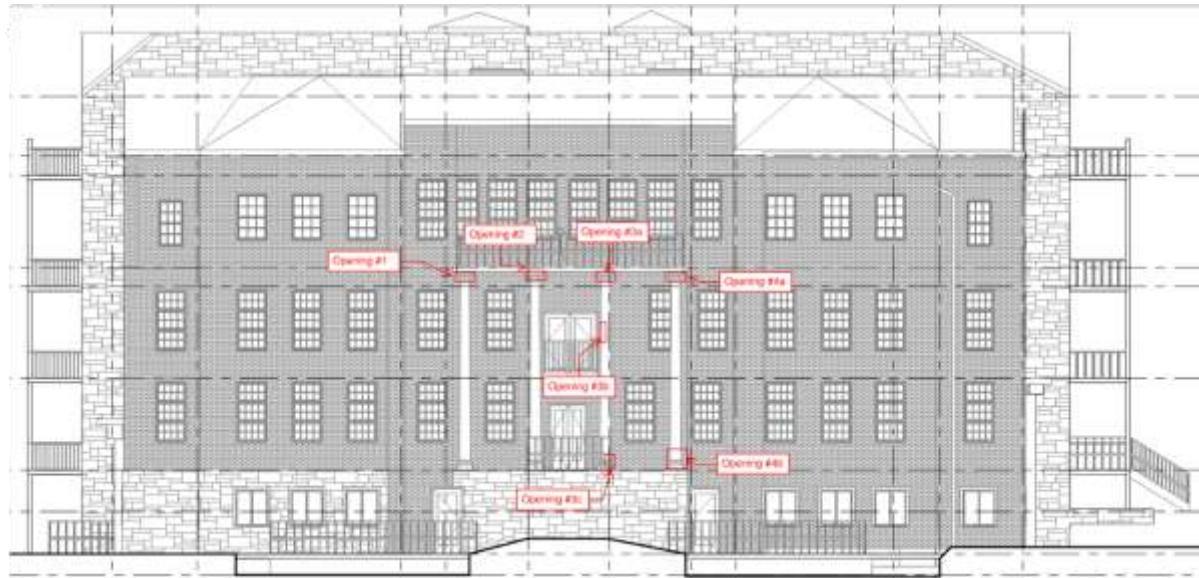
Figure 1: Approximate Locations of Column Openings, East Elevation

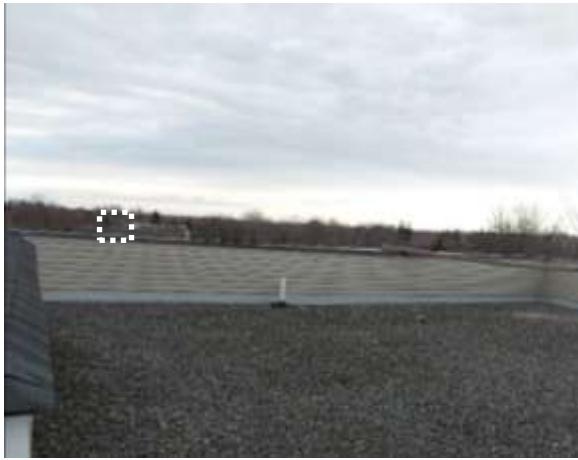
- The roof over the west addition portion of the building has a taller parapet wall, allowing access to the roof edge. The parapet wall at the west edge was previously identified as a deficiency for review. The parapet wall was noted to be unstable, when pushed manually.

Photo 12: Approximate Location of Parapet Exploratory Opening

It was recommended to immediately install a roof warning line along the perimeter to delineate a safe distance away from the parapet as per AAR's letter issued April 8, 2024.

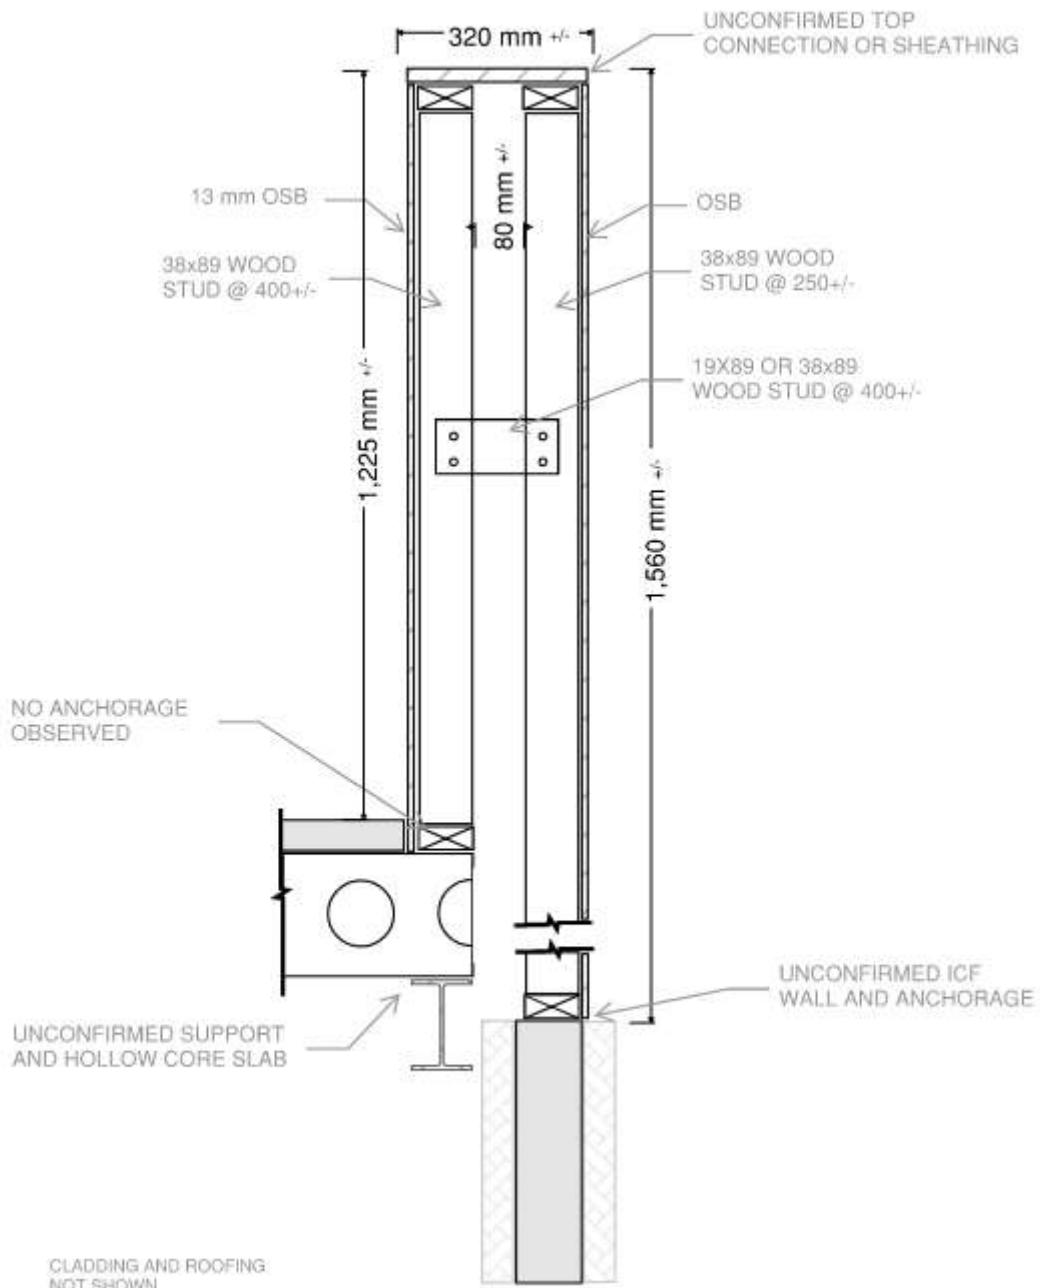
- Insufficient connections between the two sets of studs and anchorage likely contribute to the flexibility observed in the parapet wall.

Figure 2: Sketch of Expected Parapet Configuration

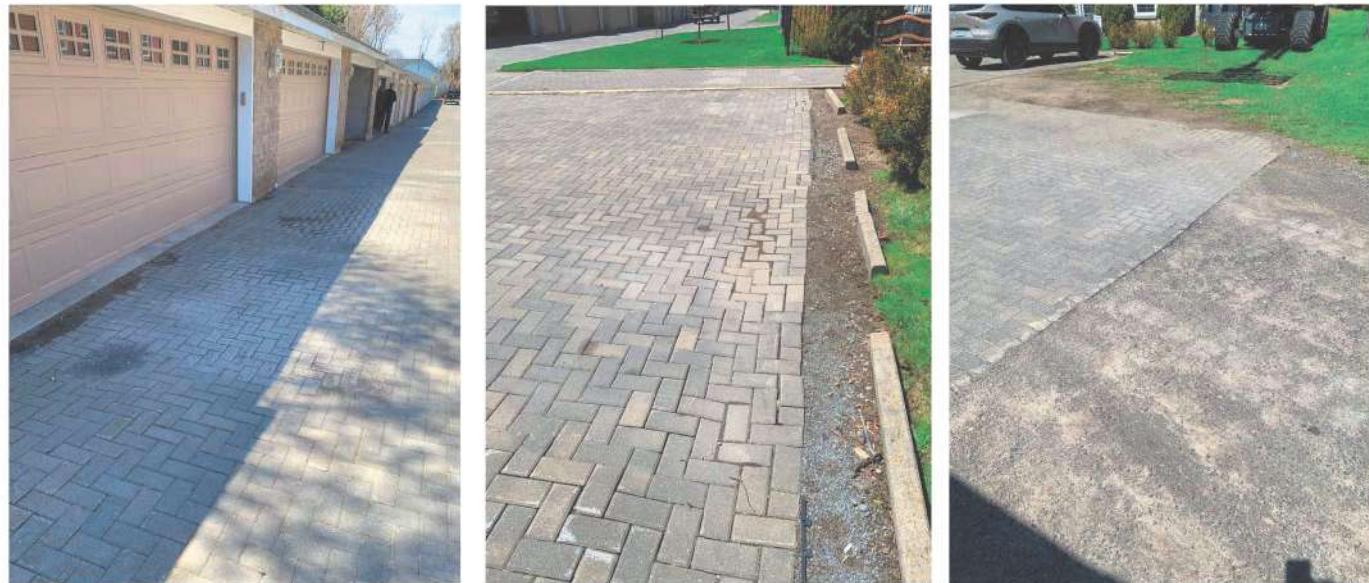
The landscaping includes a variety of deficiencies of unfinished work. This includes a poor installation of the driveway interlock, missing interlock, missing planting, pooling water, and damaged work. We also observed poor installation of the driveway interlock that has resulted in pooling, sinking and ruts. Due to the overlapping nature of many of the Pichler deficiencies, the work will include the replacement of the full area of interlock, base compaction, and re-levelling of the area for drainage. Missing areas of interlock as well as borders, will be included as part of the work.

Above: Visible defects relating to the interlock driveway: sinking and ponding, poor workmanship, missing materials.

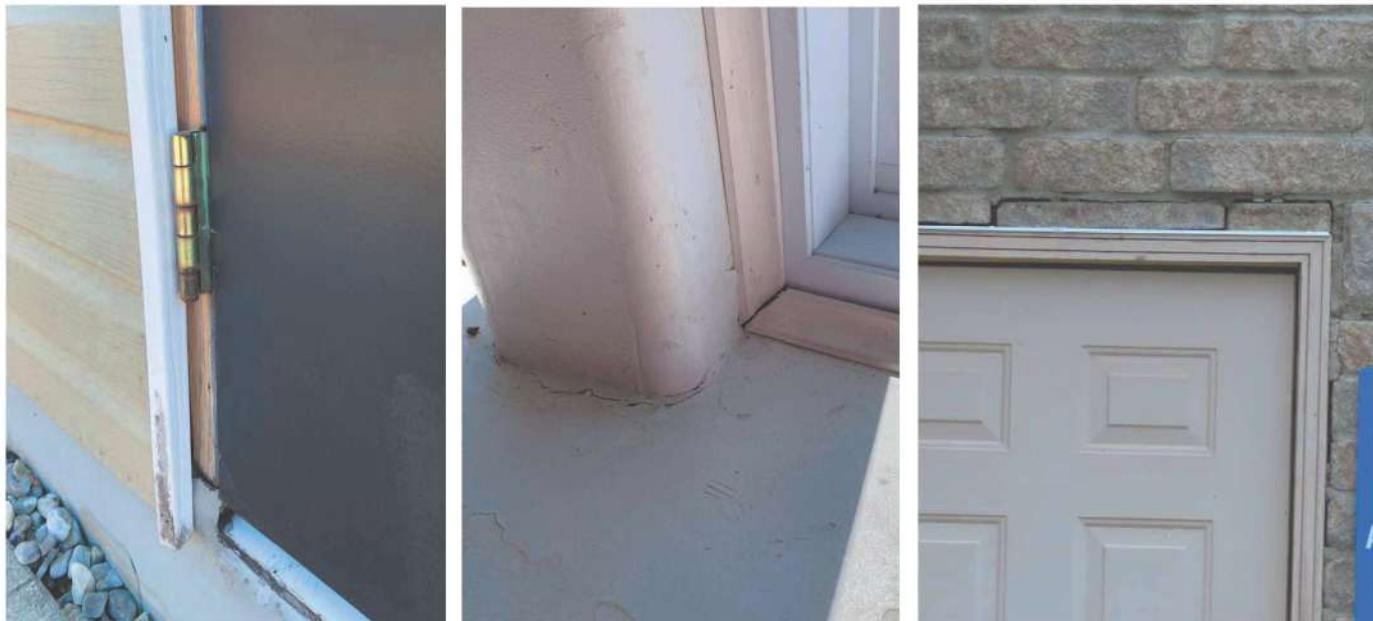
The Pichler report identified a variety of deficiencies related to exterior doors and windows. The type of deficiencies varies, but nearly all include some form of water infiltration due to bad sealants or flashing. In some cases, the contractor had returned to provide new caulking, but the interior damage was not remediated. In select instances, an improper door type had been used, which has resulted in poor performance and/or deterioration.

Above: Various deficiencies affecting exterior doors and windows.

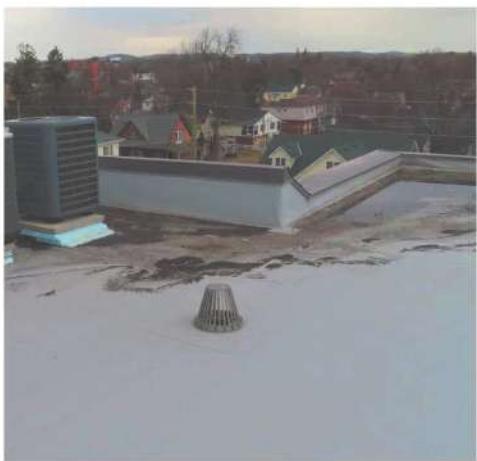
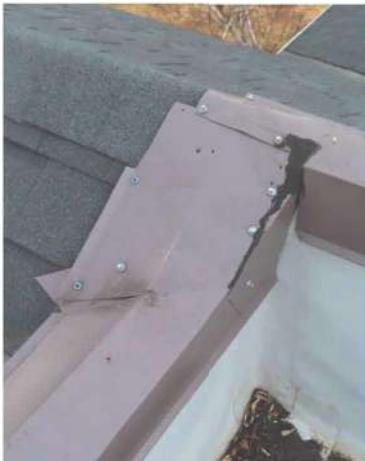
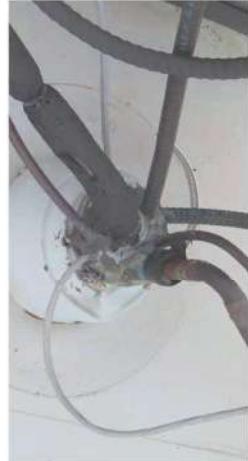
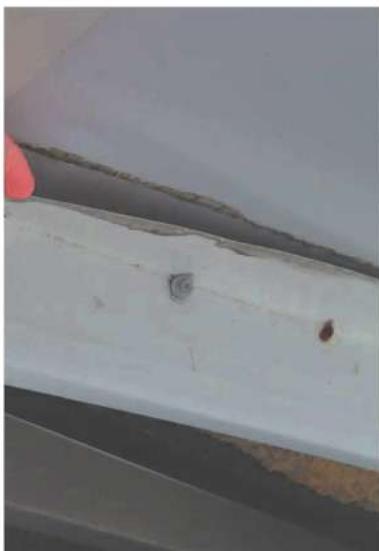
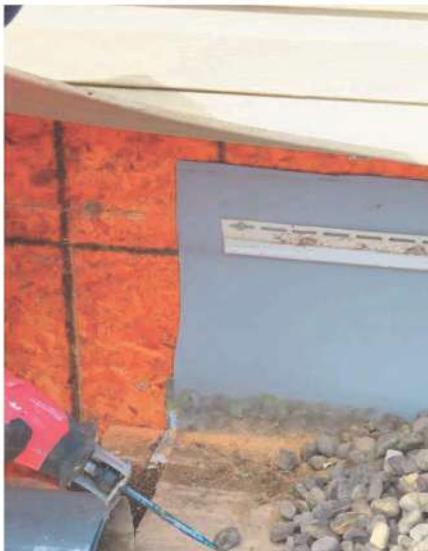
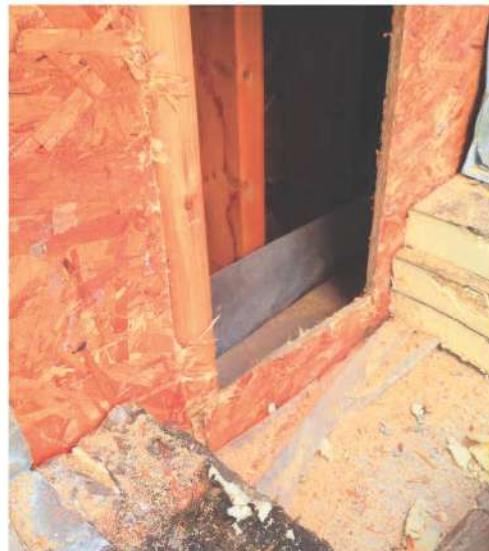
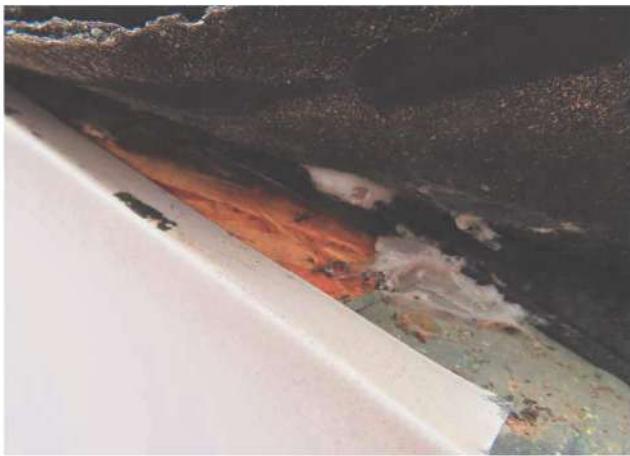
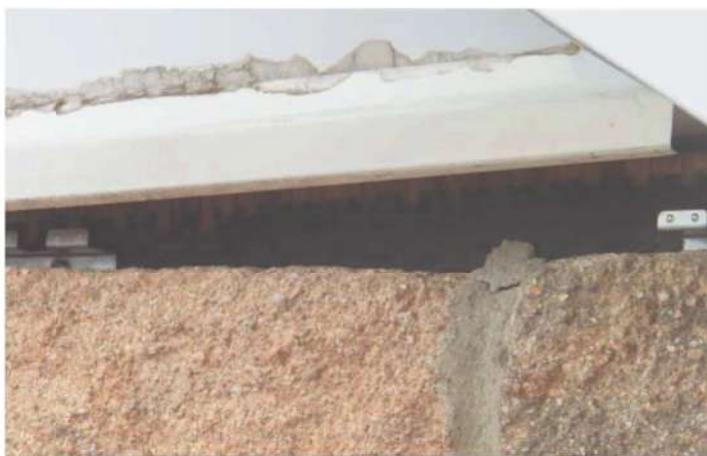
As a result of these issues, leaking has led to drywall damage on the interior. The various deficiencies have allowed water to enter the wall assembly at many locations around the building. These issues are not able to be addressed by localized repairs. The entire roofing system, including all parapets, flashing, slopes, drains should be removed and replaced with new materials.

Above: A selection of images showing the different types of roofing and waterproofing deficiencies.

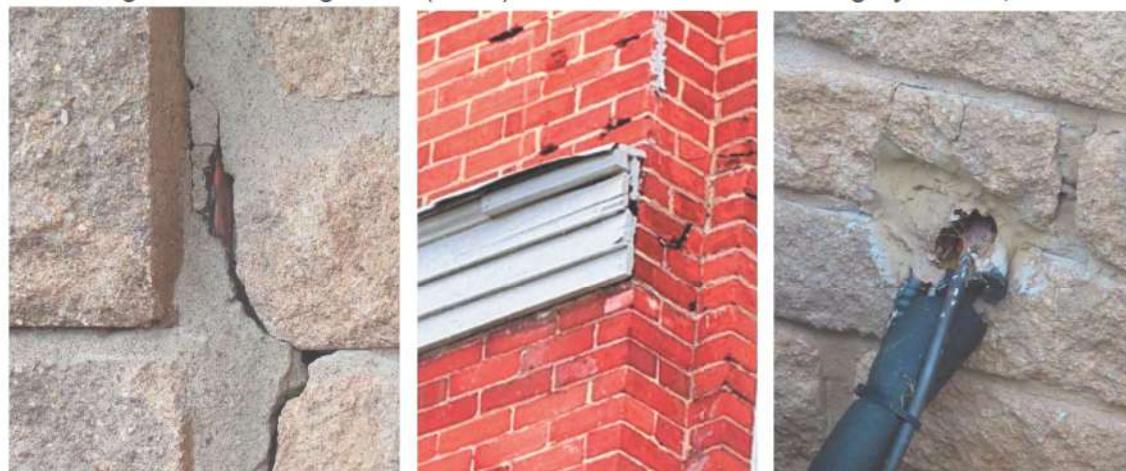
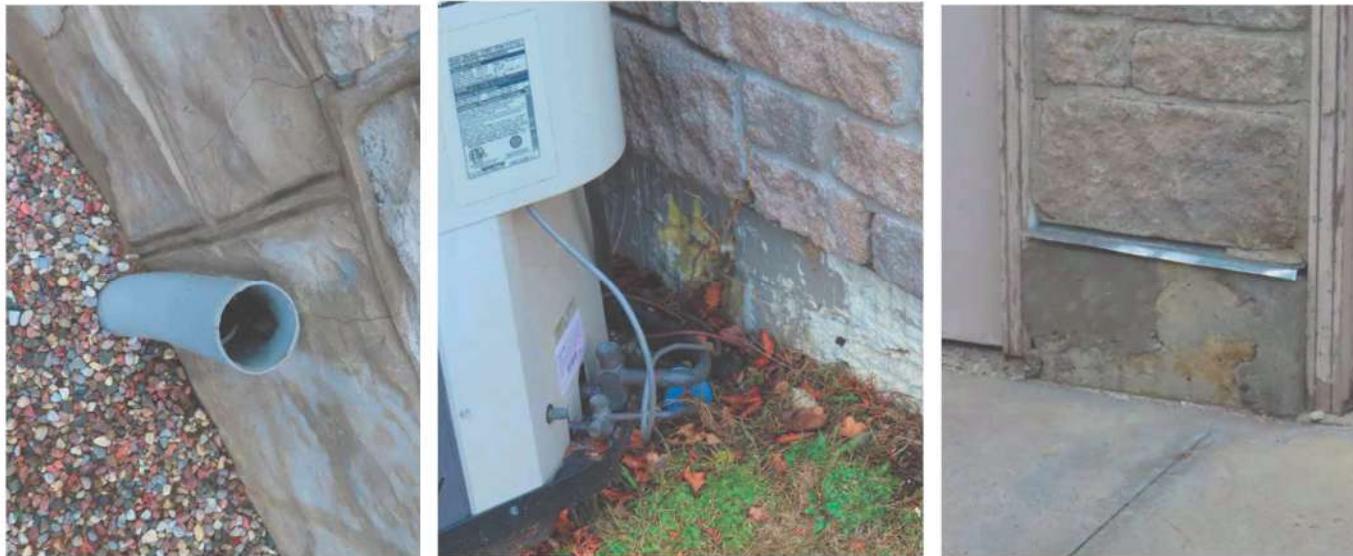
- Issues with base-of-wall flashing at the new stone veneer. These flashings had an insufficient drip edge, and were consistently back-sloped towards the building.
- Exterior louvers for unit ventilation were missing caulking in all locations.
- Veneer masonry had void mortar joints in various locations.
- Gutter downspouts had insufficient gutter extension.
- Wooden cornice was poorly constructed and flashed, leading to premature rot.
- Larger louvers adjacent to balconies on the new addition were missing a pest mesh; potentially allowing insects or vermin to enter the ductwork system.

Above: Images of some of the deficiencies observed for exterior walls.

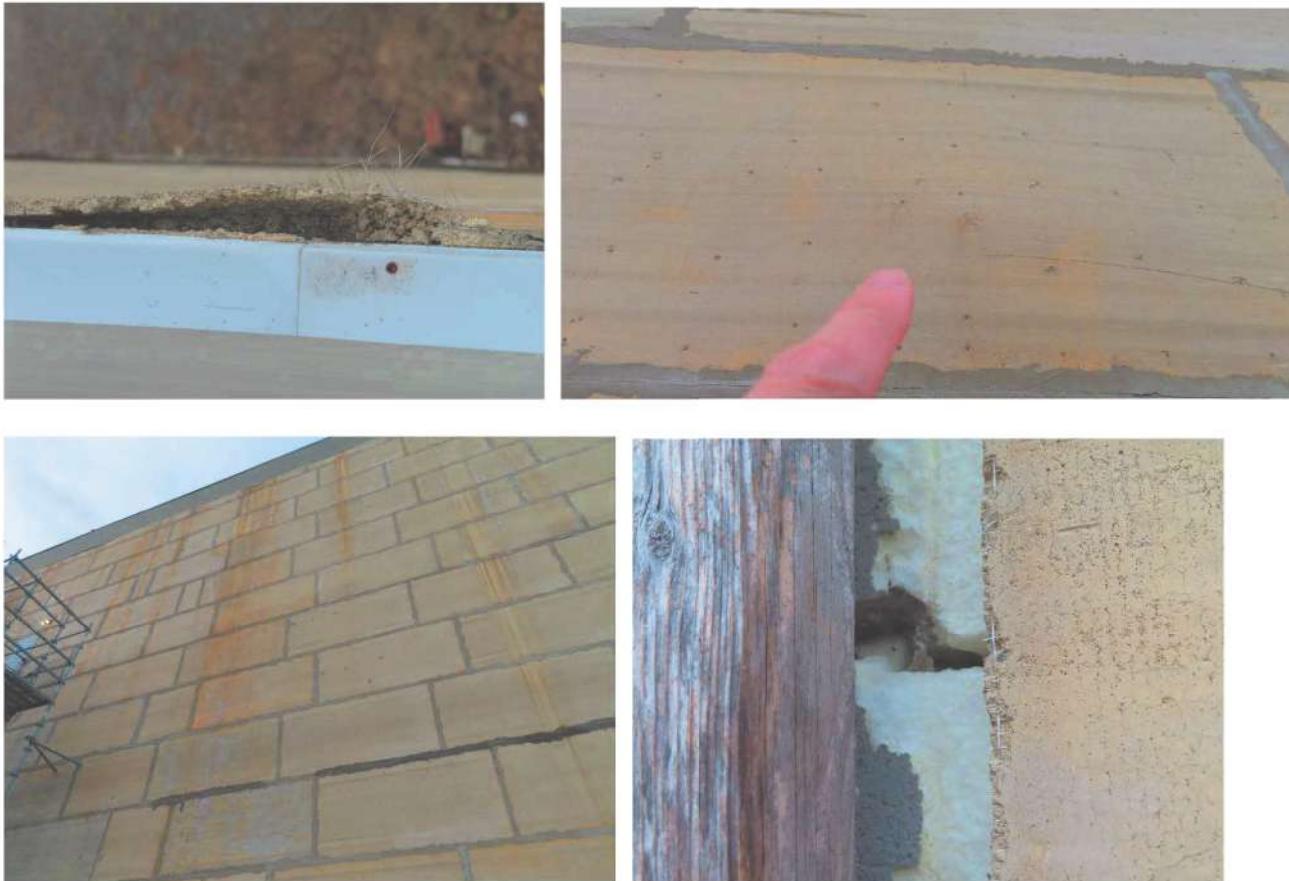
Above: Images showing some of the observed conditions, including deterioration, bulging, and exposed Styrofoam.

The solution to this problem is to remove the cement panel cladding, and to provide a new cladding system made of non-combustible construction.

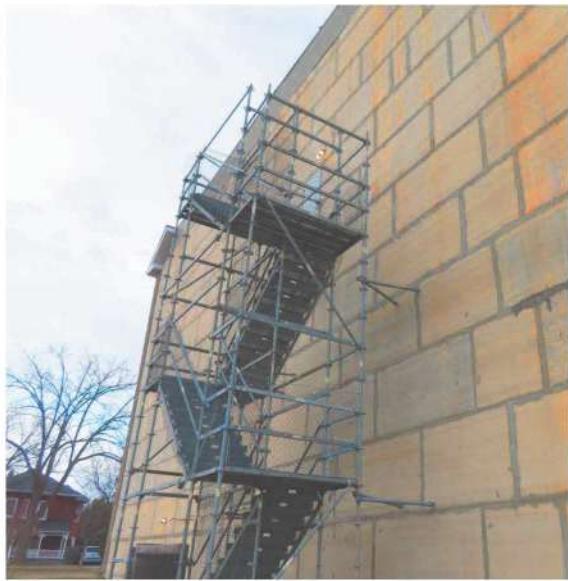
Above: The existing scaffolding stair on the west elevation.

This condition will need to be remedied in order to comply with the OBC and provide a safe means egress for the apartments on the 4th floor. This will include constructing a new permanent egress staircase, presumably an enclosed structure that connects to the west wall of the building. To accomplish this, a modification of the lot line will be required.

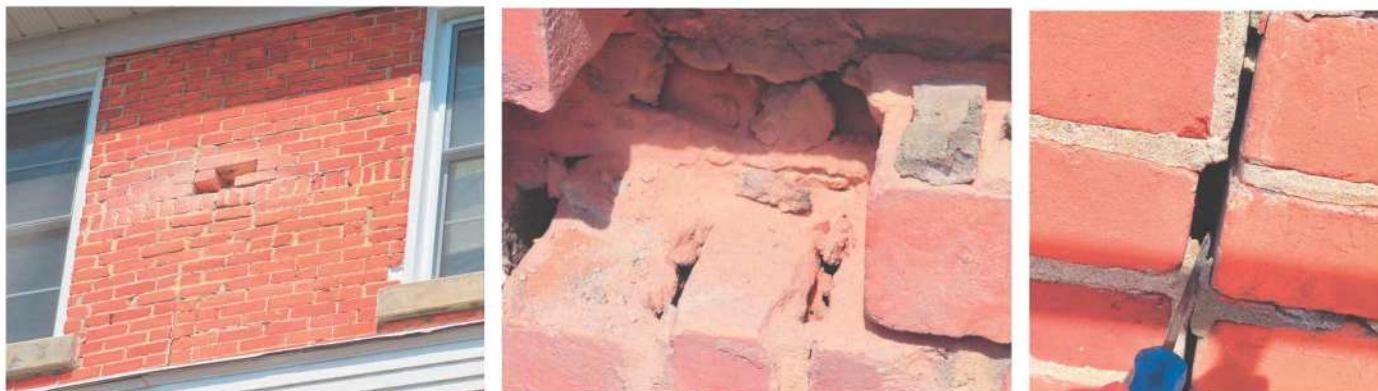
Above: One of the brick investigative openings, with visible voids inside the wall. Bulging in this location has created cracks in the face of the wall.

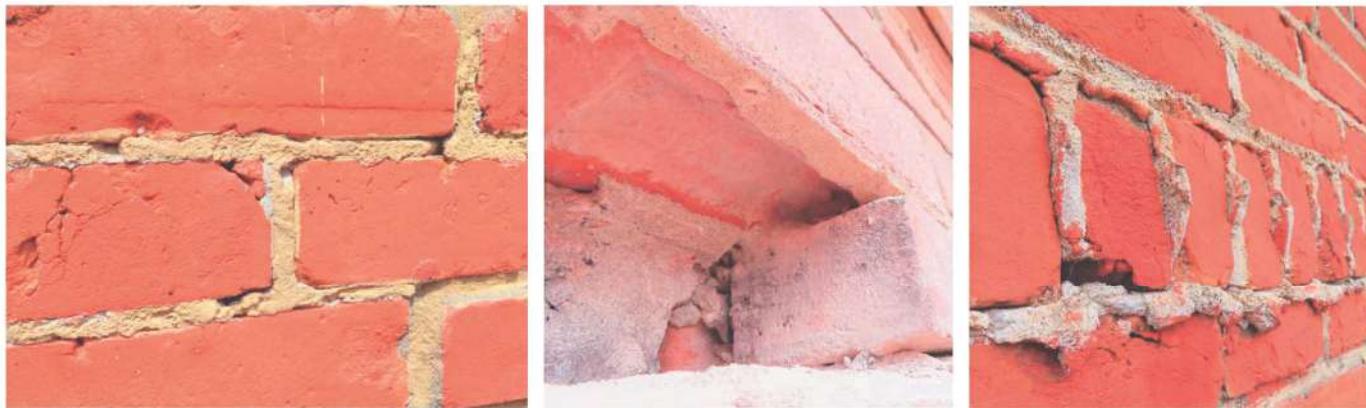
Above: Some typical conditions found on the brick masonry at the 4th floor. This mortar is not suitable for exposure to the weather.

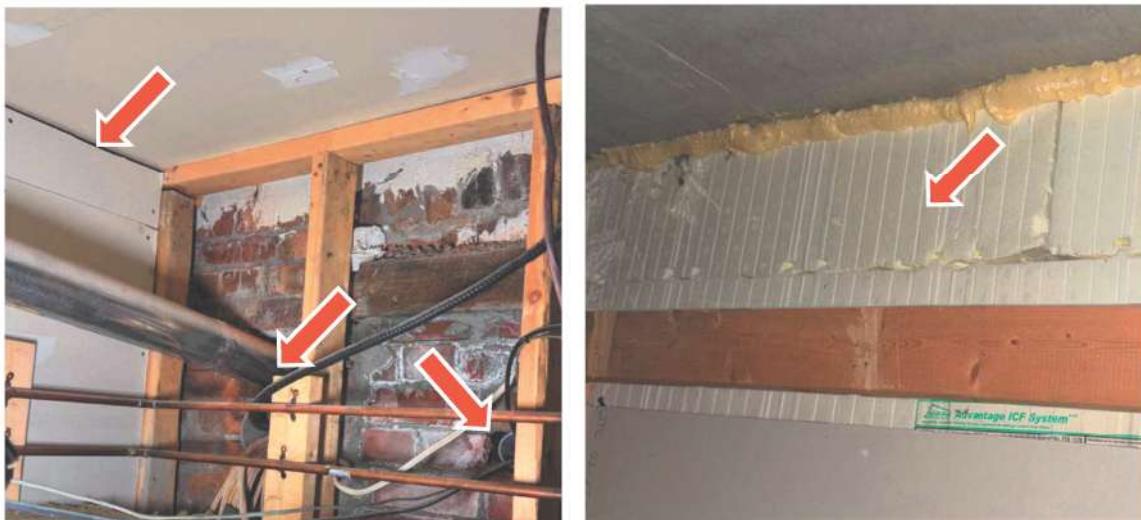
- Absence of fire-stopping at the top of gypsum demising walls.
- Absence of fire-stopping at demising wall penetrations.
- Absence of fire dampers wherever ductwork penetrates a rated assembly.
- Absence of fire-stopping at floor assembly penetrations.
- Open holes in both brick and gypsum demising walls.
- Exposed expanded polystyrene insulation within ceiling cavities of the new addition.
- Wall and ceiling assemblies that do not meet the required fire-rating for the building.

Many of these endemic deficiencies negatively affect the life-safety functions of the building and should be addressed immediately.

Above: The above images display the types of endemic deficiencies that were found in the ceiling spaces. Various fire-stopping issues on the left, and exposed polystyrene insulation on the right.
The Rough Order of Magnitude (ROM) cost estimate for this category is: **\$7,700,000.00**

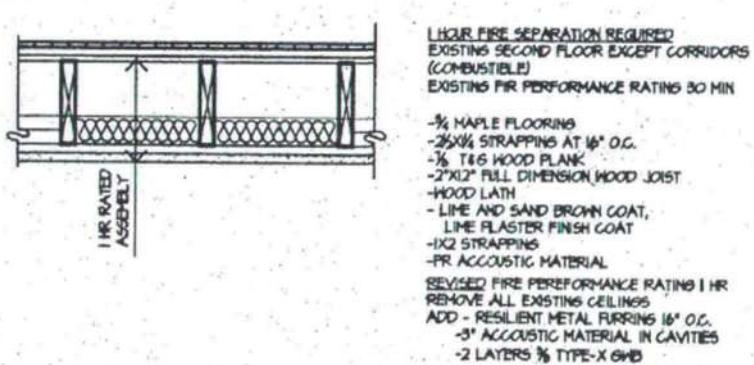
The above image is a floor assembly that claims a 1-hour rating. However, the architect has not provided a code or ULC reference to support this claim. The assembly indicates a 30minute rating for the historic plaster ceiling, which is to be left in place and have a sheet of fire-rated drywall affixed overtop. This is not permitted. SB2 of the Ontario Building Code does allow for the use of built-up assemblies; but it is a stand-alone tool and cannot be combined with historic assemblies. To properly use the built-up method of SB-2, two layers of 5/8" Type X gypsum would have been required. As a result, any floors constructed in this manner cannot be considered to have the required fire-rating.

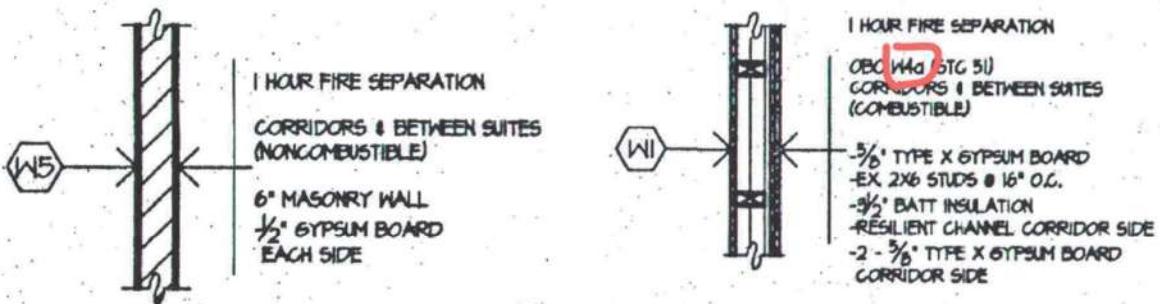
The above wall assemblies do not include code or ULC references. On the left, it is unclear whether the 6" masonry core is new or existing, or whether it is hollow-core or monolithic. On the right, the rating is applicable to Part 9 (small construction) buildings only and should not be used in this instance. We would need to perform additional investigations to determine in there is an applicable assembly that could be

retroactively applied to these wall assemblies. As designed and annotated, they do not currently meet the requirements of the OBC.

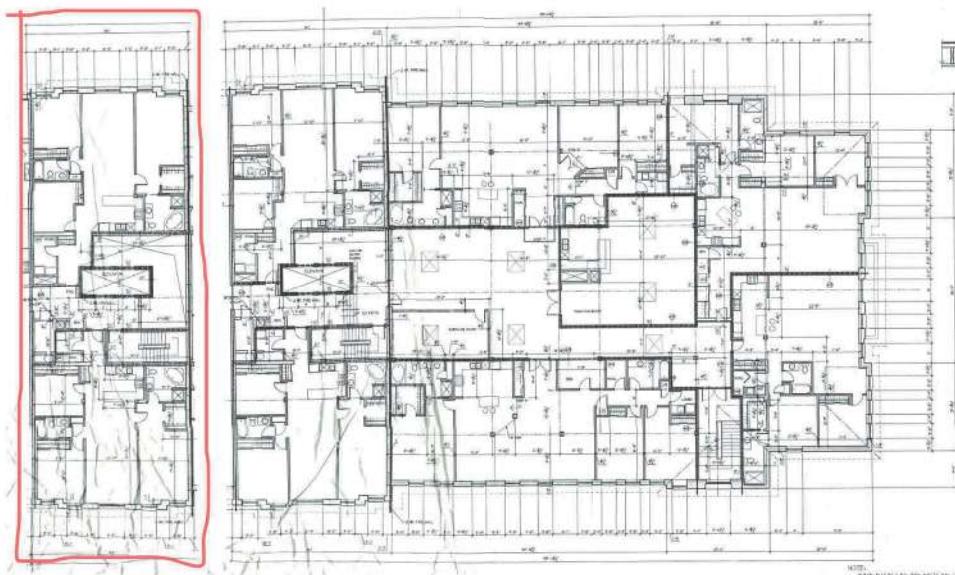
The two units on the 4th floor of the addition were not design with the proper number of exits. Two exits are required from the public corridor, and only one has been provided. In attempt to address this issue, a scaffolding exterior exit stair was provided for these two units. Nonetheless, this represents a significant design oversight.

The above image shows the units (on the left) which are not provided with sufficient exits.

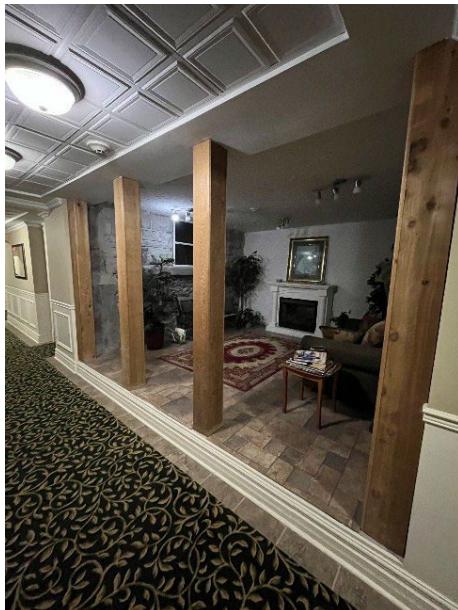
Photo 1

- a) There is no ramp to provide barrier-free access to the amenity space on the ground floor due to the change in elevation.

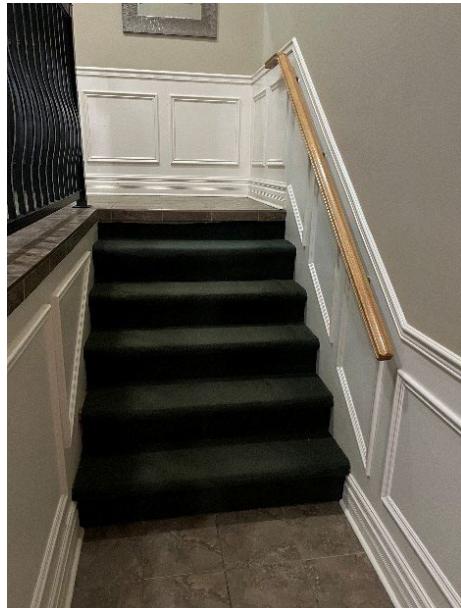
Photo 3

- There is no tactile attention indicator at the top of the stairs
- A minimum of 300 mm handrail extension was not provided at the bottom of the stairs

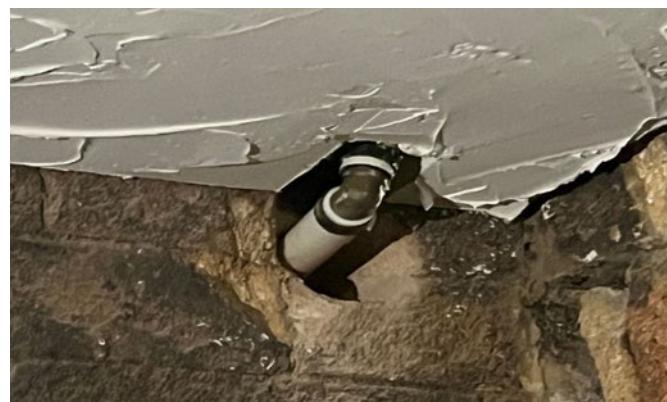
Photo 5

- There are gaps around the sprinklers in some of the rooms and at the amenity space between residential units on the ground floor
- Gaps are observed between the precast slabs for the second floor that will need to be firestopped (as seen from the compactor room, *service rooms on the ground floor*)
