Building Deficiency Review

at 323 George Street, Coburg, ON

Final Submission

PROJECT # 6383-01

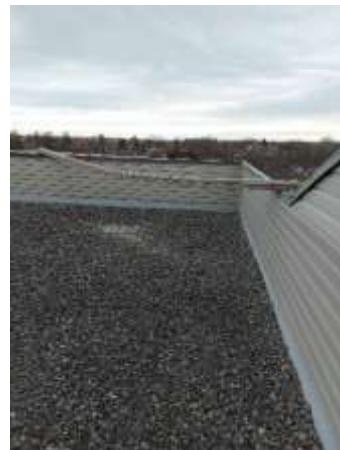
- A diagonal brace was also noted at the non-public area of the roof between the west parapet wall and the north parapet wall. The brace was a make-shift wood member with significant drooping. (*Photo 3*)

Photo 3: Diagonal Brace, West Parapet

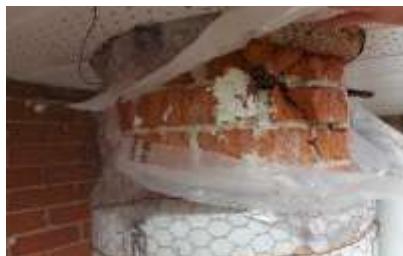
Photo 8: Opening 2a

- Where exposed, the brick condition was found to be generally poor. (*Photo 7 & Photo 8*) Bricks were noted to be soft, crumbling, and spalling. Mortar condition was also found to be generally poor. Mortar was found to be soft, sandy, and crumbling.

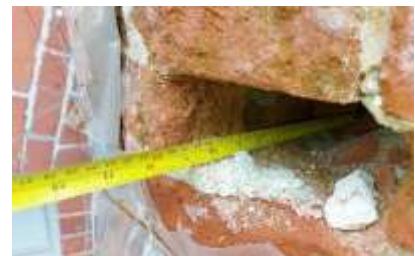
- At the mid-height opening (Opening #3b) (*Photo 9*), the column was open to a depth of approximately 280 mm [11"] deep, to the center of the column. It is assumed bricks were previously removed for review; however, the extent is unclear, and the interior of the column was generally found to be soft and crumbling. There did not appear to be an interior structural member such as steel or concrete; it is therefore assumed that the existing brick columns are load bearing.

Photo 9: Opening 3b

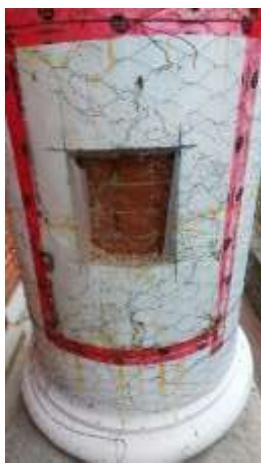
- At the bottom opening (Opening #4b) (*Photo 10*) the brick, mortar and parging appeared to be in fair to good condition. This area did not appear to have the significant moisture damage and deterioration observed in other areas.

Photo 10: Opening 4b

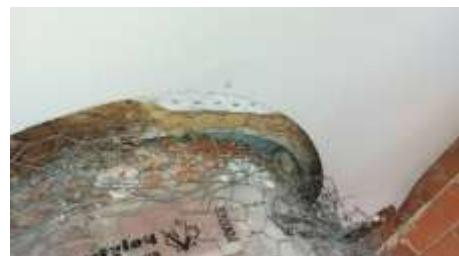
Photo 11: Opening 1a

- Soffit plywood was noted to be wet and rot. Only small portions of the soffit plywood were visible at the time of review. (*Photo 11*) Waterproofing had been redone at the top side of the balcony as noted above, *Section 3.2*.

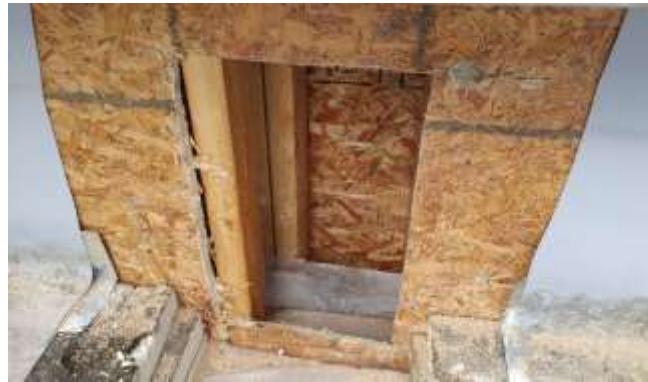
An exploratory opening was conducted at the parapet at the west roof. An opening approximately 300 mm x 600 mm was made at the interior face of the parapet wall near the roof line. (Photo 12 & Photo 13) The following observations were noted regarding the structure, refer also to Figure 2. Refer also to architectural report.

Photo 13: Parapet Wood Framing at Exploratory Opening

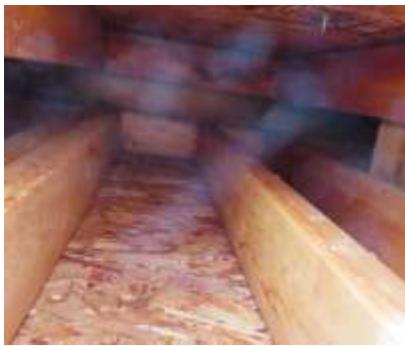
- Stud spacing at the interior side of the wall was approximately 400 mm. Top and bottom plates (2x4 [38 mm x 89 mm]) were noted at the top of the wall and at the roof level. No anchorage or fasteners were noted at the bottom plate to the roof structure, which likely contributes to the flexibility of the parapet wall. (Photo 14Photo 15)

- Stud spacing at the exterior side of the wall was approximately 250 mm. A top plate (2x4 [38 mm x 89 mm]) was noted at the top of the wall; however, the bottom plate was not visible. Studs continued below the roof level. (Photo 14Photo 15) It is assumed the studs connect to the concrete (ICF) wall below.

Photo 14: Parapet Wall Composition, (looking up) [Photo by Juxta, 2025]

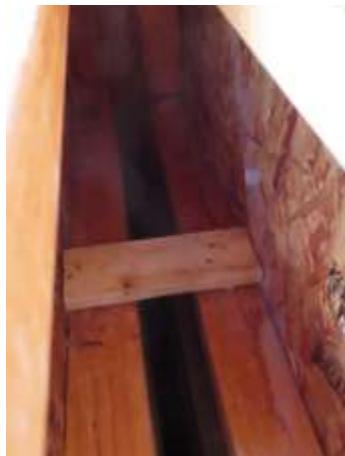
Photo 15: Parapet Wall Composition, (mid-height brace) [Photo by Juxta, 2025]

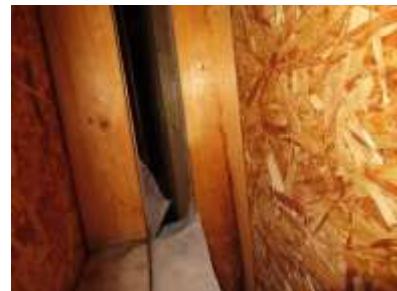
- 1x4 [19 mm x 89 mm] or 2x4 [38 mm x 89 mm] members were noted to be spaced intermittently connecting the two sets of wood studs. (Photo 16) The spacing of connecting members was not confirmed; however, was noted to be infrequent.

Photo 16: Parapet Wall Composition, (looking down) [Photo by Juxta, 2025]

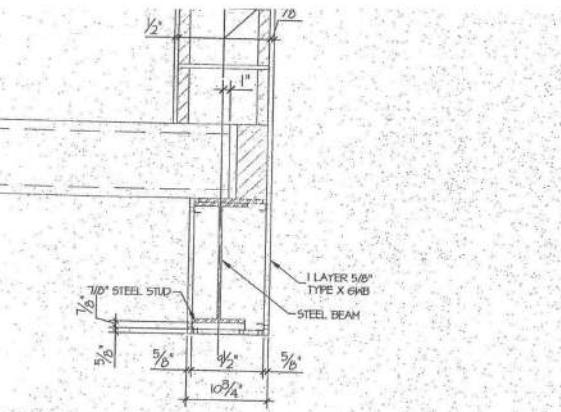
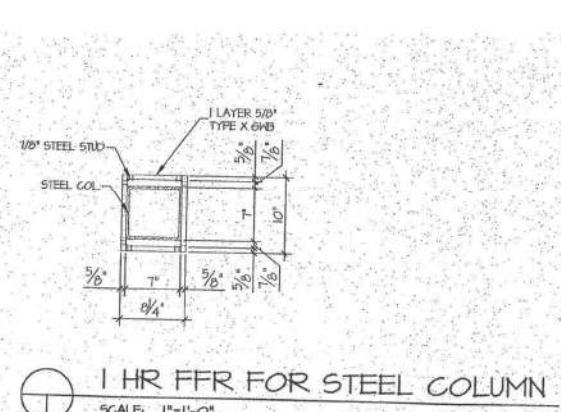
1 HR FFR FOR STEEL BEAM
SCALE: 1"=1'-0"

1 HR FFR FOR STEEL COLUMN
SCALE: 1"=1'-0"

The above images are the fire protection details for steel beams and columns, respectively. Both details are assigned a 1-hour rating, but the detail is incorrect: two layers of Type X gypsum is required to achieve the required rating. Based on these details, it is possible that the steel beams and columns throughout the building are not provided with adequate fire protection.

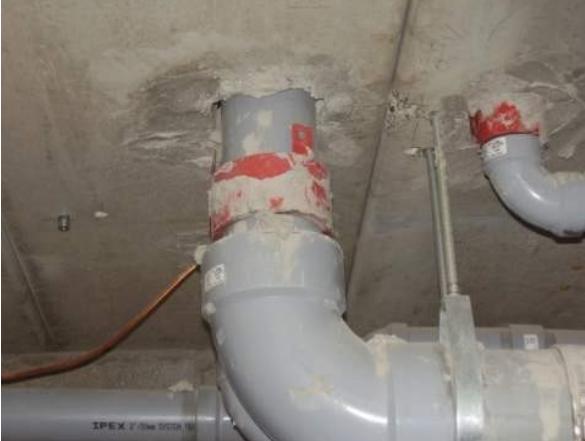
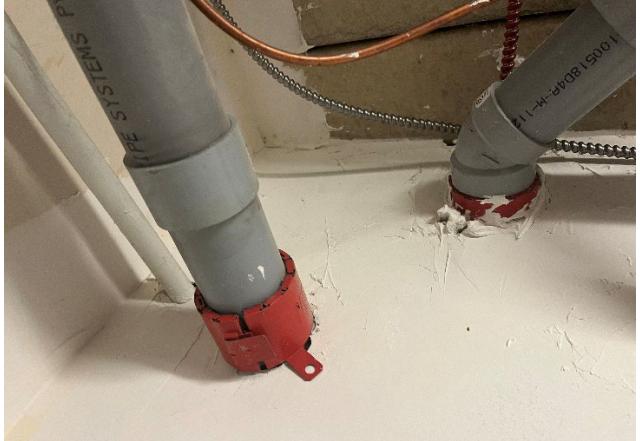
67	Missing/incomplete fire stopping	Compactor room	Verify	Not yet resolved	The holes appear to have been covered with a material that is not consistent with the firestop system we are familiar with. As such, we cannot verify whether the installed material complies with CAN/ULC-S115, "Standard Method of Fire Tests of Firestop Systems," as a firestop system in accordance with Article 3.1.9.1.	\$50,000 (lump sum for firestop issues in the building)
68	Missing/incomplete fire stopping	Electrical room	Verify	Not yet resolved	The holes appear to have been covered with a material that is not consistent with the firestop system we are familiar with. As such, we cannot verify whether the installed material complies with CAN/ULC-S115, "Standard Method of Fire Tests of Firestop Systems," as a firestop system in accordance with Article 3.1.9.1. See the photo for item 72 in Appendix B	\$50,000 (lump sum for firestop issues in the building)

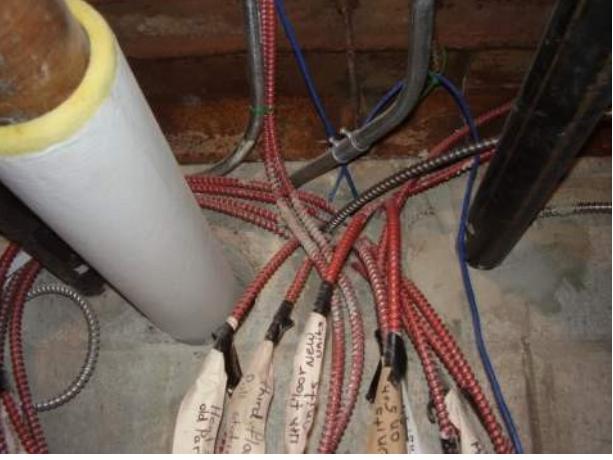
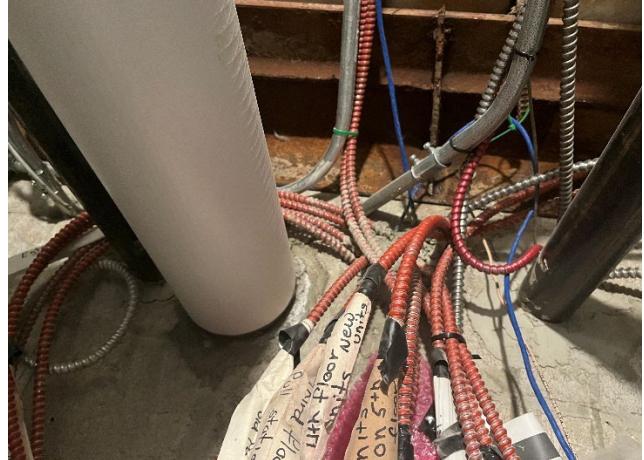
Pre- Existing Reference #	Pictures from Performance Audit Report, prepared by Pichler Engineering™	Pictures taken by LRI during BCA
91

91	Piping and wiring not fire stopped	Electrical room, 1st floor	To be resolved	Not yet resolved	<p>The holes appear to have been covered with a material that is not consistent with the firestop system we are familiar with. As such, we cannot verify whether the installed material complies with CAN/ULC-S115, "Standard Method of Fire Tests of Firestop Systems," as a firestop system in accordance with Article 3.1.9.1.</p> <p>See the photo for item 91 in Appendix B</p>	\$50,000 (lump sum for firestop issues in the building)
93	Fire stopping missing around card access conduit	Electrical room, 1st floor	To be resolved	Not yet resolved	<p>The holes appear to have been covered with a material that is not consistent with the firestop system we are familiar with. As such, we cannot verify whether the installed material complies with CAN/ULC-S115, "Standard Method of Fire Tests of Firestop Systems," as a firestop system in accordance with Article 3.1.9.1.</p> <p>See the photo for item 94 in Appendix B</p>	\$50,000 (lump sum for firestop issues in the building)

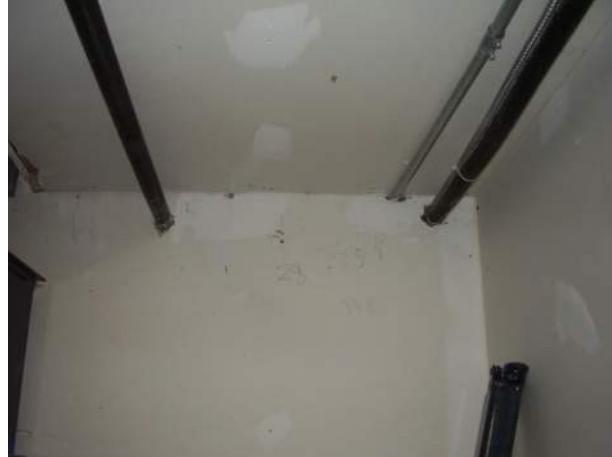
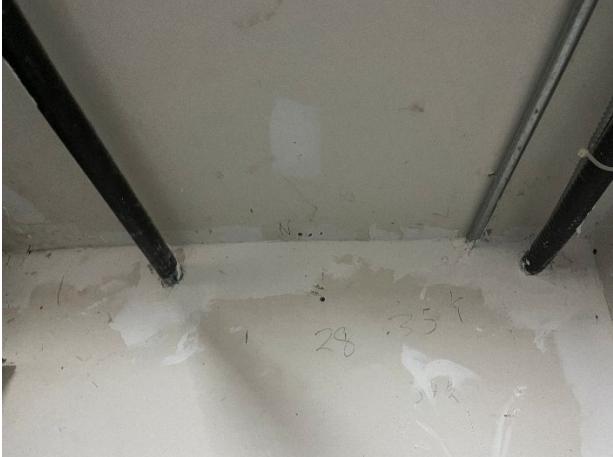
Pre-Existing Reference #	Pictures from Performance Audit Report, prepared by Pichler Engineering"	Pictures taken by LRI during BCA
96	No Photo	No photo for comparison
98

94	Fire stopping missing around opening in ceiling.	Electrical room, 1st floor	To be resolved	Not yet resolved	<p>The holes appear to have been covered with a material that is not consistent with the firestop system we are familiar with. As such, we cannot verify whether the installed material complies with CAN/ULC-S115, "Standard Method of Fire Tests of Firestop Systems," as a firestop system in accordance with Article 3.1.9.1.</p>	\$50,000 (lump sum for firestop issues in the building)
96	Fire stopping missing at pipe and wire wall penetrations	Utility room "B", 1st floor	To be resolved	Not yet resolved	<p>The hole is yet to be covered with a ULC-listed firestop material.</p>	\$50,000 (lump sum for firestop issues in the building)
98 (Same as #67)	Fire stopping missing around north wall penetration	Garbage compactor room	To be resolved	Not yet resolved	<p>The holes appear to have been covered with a material that is not consistent with the firestop system we are familiar with. As such, we cannot verify whether the installed material complies with CAN/ULC-S115, "Standard Method of Fire Tests of Firestop Systems," as a firestop system in accordance with Article 3.1.9.1.</p> <p>See the photo for item 98 in Appendix B</p>	\$50,000 (lump sum for firestop issues in the building)

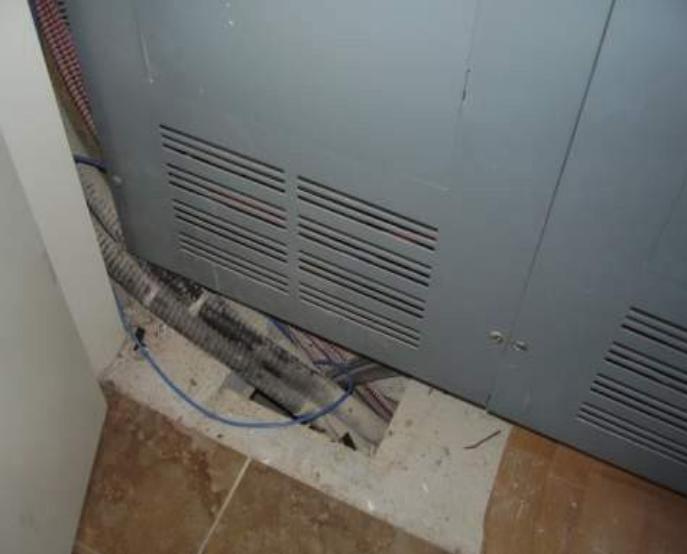
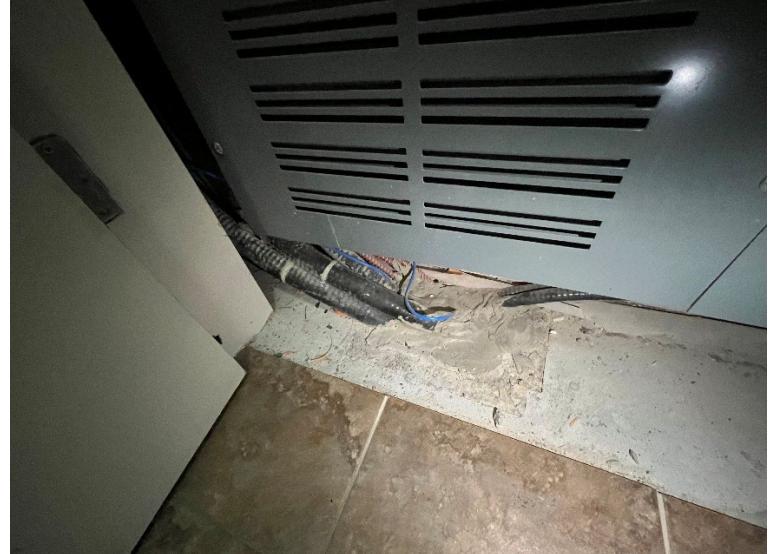
Pre- Existing Reference #	Pictures from Performance Audit Report, prepared by Pichler Engineering™	Pictures taken by LRI during BCA
102

101	Fire stopping missing around floor penetrations	North electrical closet, 4th floor	To be resolved	Not yet resolved	<p>The holes appear to have been covered with a material that is not consistent with the firestop system we are familiar with. As such, we cannot verify whether the installed material complies with CAN/ULC-S115, "Standard Method of Fire Tests of Firestop Systems," as a firestop system in accordance with Article 3.1.9.1.</p> <p>See the photo for item 101 in Appendix B</p>	\$50,000 (lump sum for firestop issues in the building)
102	Fire stopping missing around floor penetrations	North electrical closet, 3rd floor	To be resolved	Not yet resolved	<p>The holes appear to have been covered with a material that is not consistent with the firestop system we are familiar with. As such, we cannot verify whether the installed material complies with CAN/ULC-S115, "Standard Method of Fire Tests of Firestop Systems," as a firestop system in accordance with Article 3.1.9.1.</p> <p>See the photo for item 102 in Appendix B</p>	\$50,000 (lump sum for firestop issues in the building)

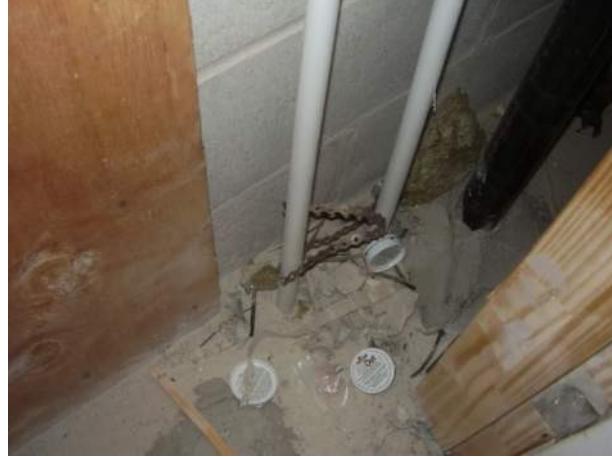
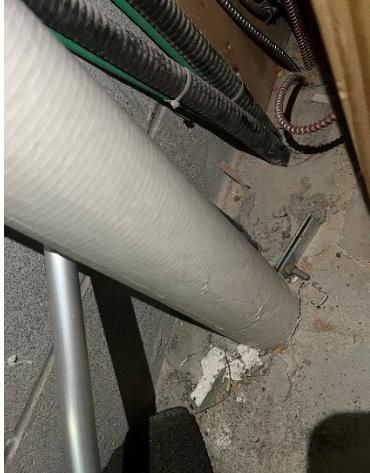
103	Fire stopping missing around floor penetrations	"K" Utility room, 2nd floor	To be resolved	Not yet resolved	<p>The hole is yet to be covered with a ULC-listed firestop material.</p> <p>See the photo for item 103 in Appendix B</p>	\$50,000 (lump sum for firestop issues in the building)
104	Fire stopping missing around floor penetrations	"I" and "J" Utility rooms, 2nd floor	To be resolved	Not yet resolved	<p>The holes appear to have been covered with a material that is not consistent with the firestop system we are familiar with. As such, we cannot verify whether the installed material complies with CAN/ULC-S115, "Standard Method of Fire Tests of Firestop Systems," as a firestop system in accordance with Article 3.1.9.1.</p>	\$50,000 (lump sum for firestop issues in the building)
105	Fire stopping missing around floor penetrations	"H" Utility room, 2nd floor	To be resolved		Utility room "H" could not be found

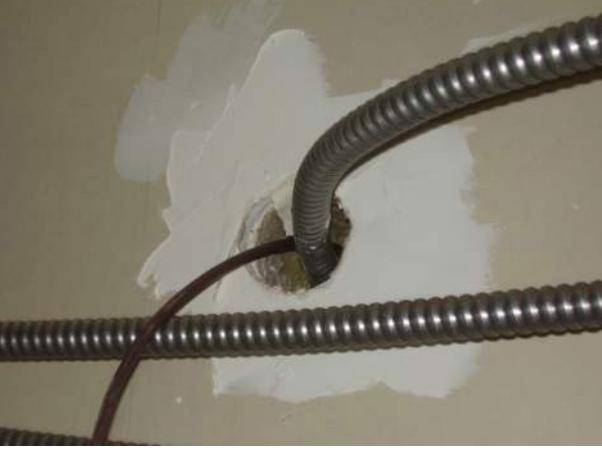
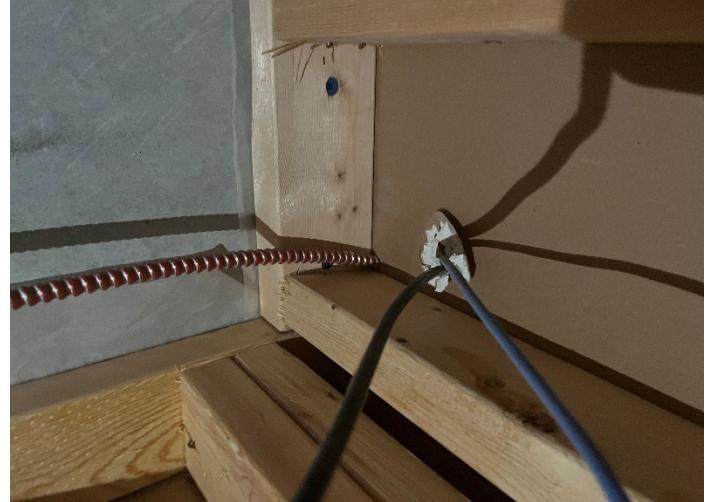
110	Fire stopping missing around ceiling penetrations	Drywall ceiling in hallway, east of suite 309	To be resolved	Not yet resolved	The holes appear to have been covered with a material that is not consistent with the firestop system we are familiar with. As such, we cannot verify whether the installed material complies with CAN/ULC-S115, "Standard Method of Fire Tests of Firestop Systems," as a firestop system in accordance with Article 3.1.9.1. See the photo for item 110 in Appendix B	\$50,000 (lump sum for firestop issues in the building)
111	Missing fire stopping	Wall above double doors, 2nd & 3rd floor	To be resolved	Not yet resolved	The hole is yet to be covered with a ULC-listed firestop material. See the photo for item 111 in Appendix B	\$50,000 (lump sum for firestop issues in the building)
117	Fire stopping missing	Wall opposing suite 204	To be resolved	Not yet resolved	The hole is yet to be covered with a ULC-listed firestop material. See the photo for item 117 in Appendix B	\$50,000 (lump sum for firestop issues in the building)

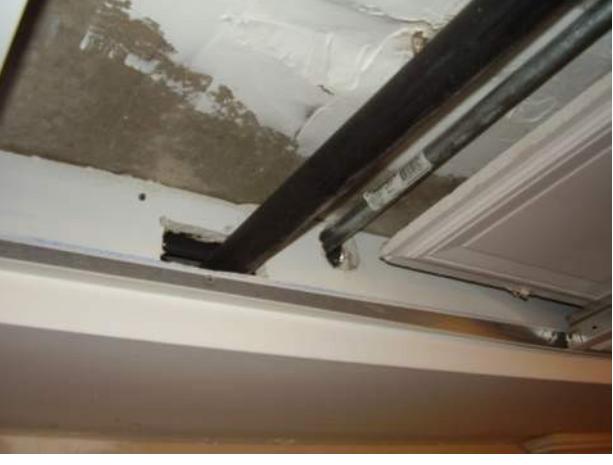
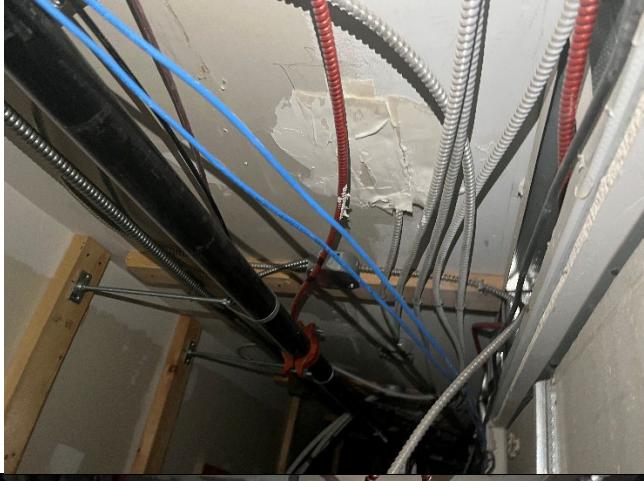
Pre-Existing Reference #	Pictures from Performance Audit Report, prepared by Pichler Engineering"	Pictures taken by LRI during BCA
118

118	Fire stopping missing around wall penetration	Locker room "F", above ceiling tile	To be resolved	Not yet resolved	The holes appear to have been covered with a material that is not consistent with the firestop system we are familiar with. As such, we cannot verify whether the installed material complies with CAN/ULC-S115, "Standard Method of Fire Tests of Firestop Systems," as a firestop system in accordance with Article 3.1.9.1. See the photo for item 118 in Appendix B	\$50,000 (lump sum for firestop issues in the building)
120	Fire stopping missing around wall penetration	Wall above door to suite 104	To be resolved	Not yet resolved	The hole is yet to be covered with a ULC-listed firestop material. See the photo for item 120 in Appendix B	\$50,000 (lump sum for firestop issues in the building)
127 (Gym)	Fire stopping ineffective, power outlet for sump pump	Crawl space, West of exercise room	Verify	Not yet resolved	The hole is yet to be covered with a ULC-listed firestop material.	\$50,000 (lump sum for firestop issues in the building)
